# **Inspect It, Inc.**

**Home**  
6291 East Fillmore Lane  
Pompano Beach, Fla. 33069

**Inspection Date**

Wednesday, August 11, 2004

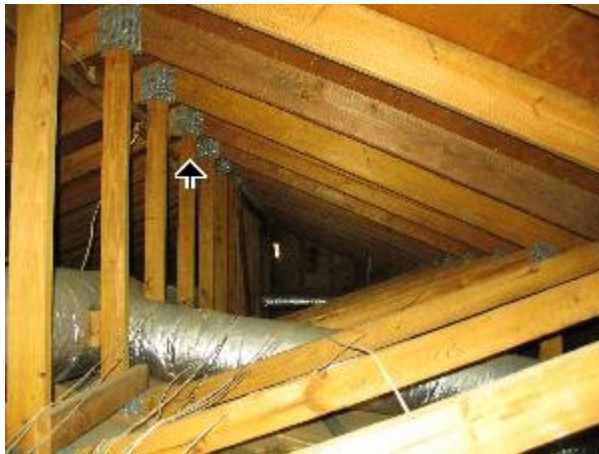
An electrical wire is damaged/exposed in attic space and should be repaired. Any electrical repairs/work to be performed should be done by a Certified Electrical Contractor.

1.5	<b>ATTIC</b> <b>Inspected</b> An electrical wire is damaged/exposed in attic space and should be repaired. Any electrical repairs/work to be performed should be done by a Certified Electrical Contractor.	\$101 - \$250
-----	---	---------------

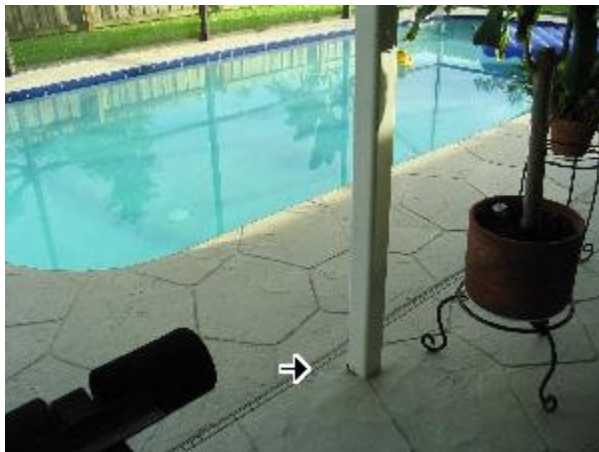
Patio roof steel poles are rusted at bottom and need repair.

2.4	<b>DECKS, BALCONIES, STOOPS, STEPS, AREAWAYS, PORCHES AND APPLICABLE RAILINGS</b> <b>Inspected</b> Patio roof steel poles are rusted at bottom and need repair.	\$101 - \$250
-----	---	---------------

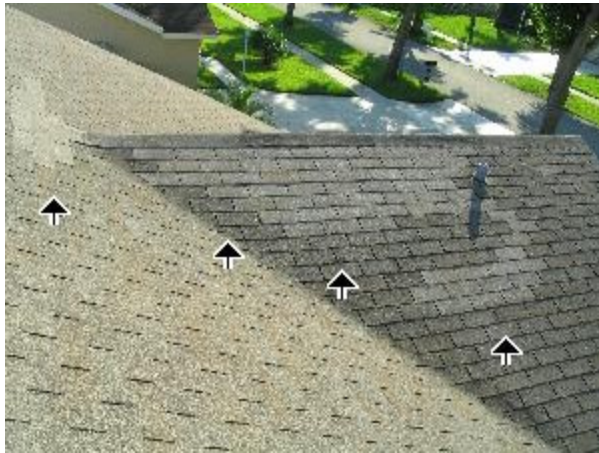
Picture 1

**Comments:** Inspected  
Some repair has been made at roof covering and appears to be in good condition.

3.0	<b>ROOF COVERINGS</b> <b>Inspected</b> Some repair has been made at roof covering and appears to be in good condition.	
-----	--	--

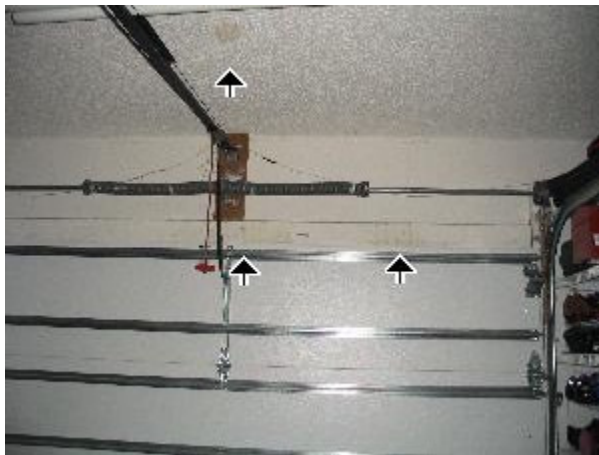
Picture 1

**Comments:** Inspected Ceiling in garage, and guest bedroom has water stains/damage present, These conditions lead me to believe there could be possible mold contamination. Samples should be taken in the area to determine if mold is present.

Ceiling in garage, and guest bedroom has water stains/damage present, These conditions lead me to believe there could be possible mold contamination. Samples should be taken in the area to determine if mold is present.

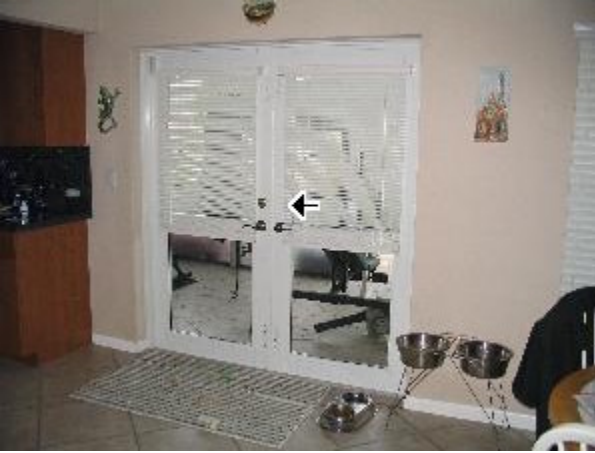
**Comments:** Inspected  
Patio French Door lock mechanism is difficult to operate, adjustment is necessary.
